PHASE 2 REPORT AND WORK PLAN
CHARACTERIZATION OF CAULK IN CONCRETE PAVEMENTS
AT BOEING PLANT 2

Boeing Plant 2
Seattle/Tukwila, Washington

October 2008

Golder Associates Inc.
18300 NE Union Hill Rd, Suite 200
Redmond, Washington 98052

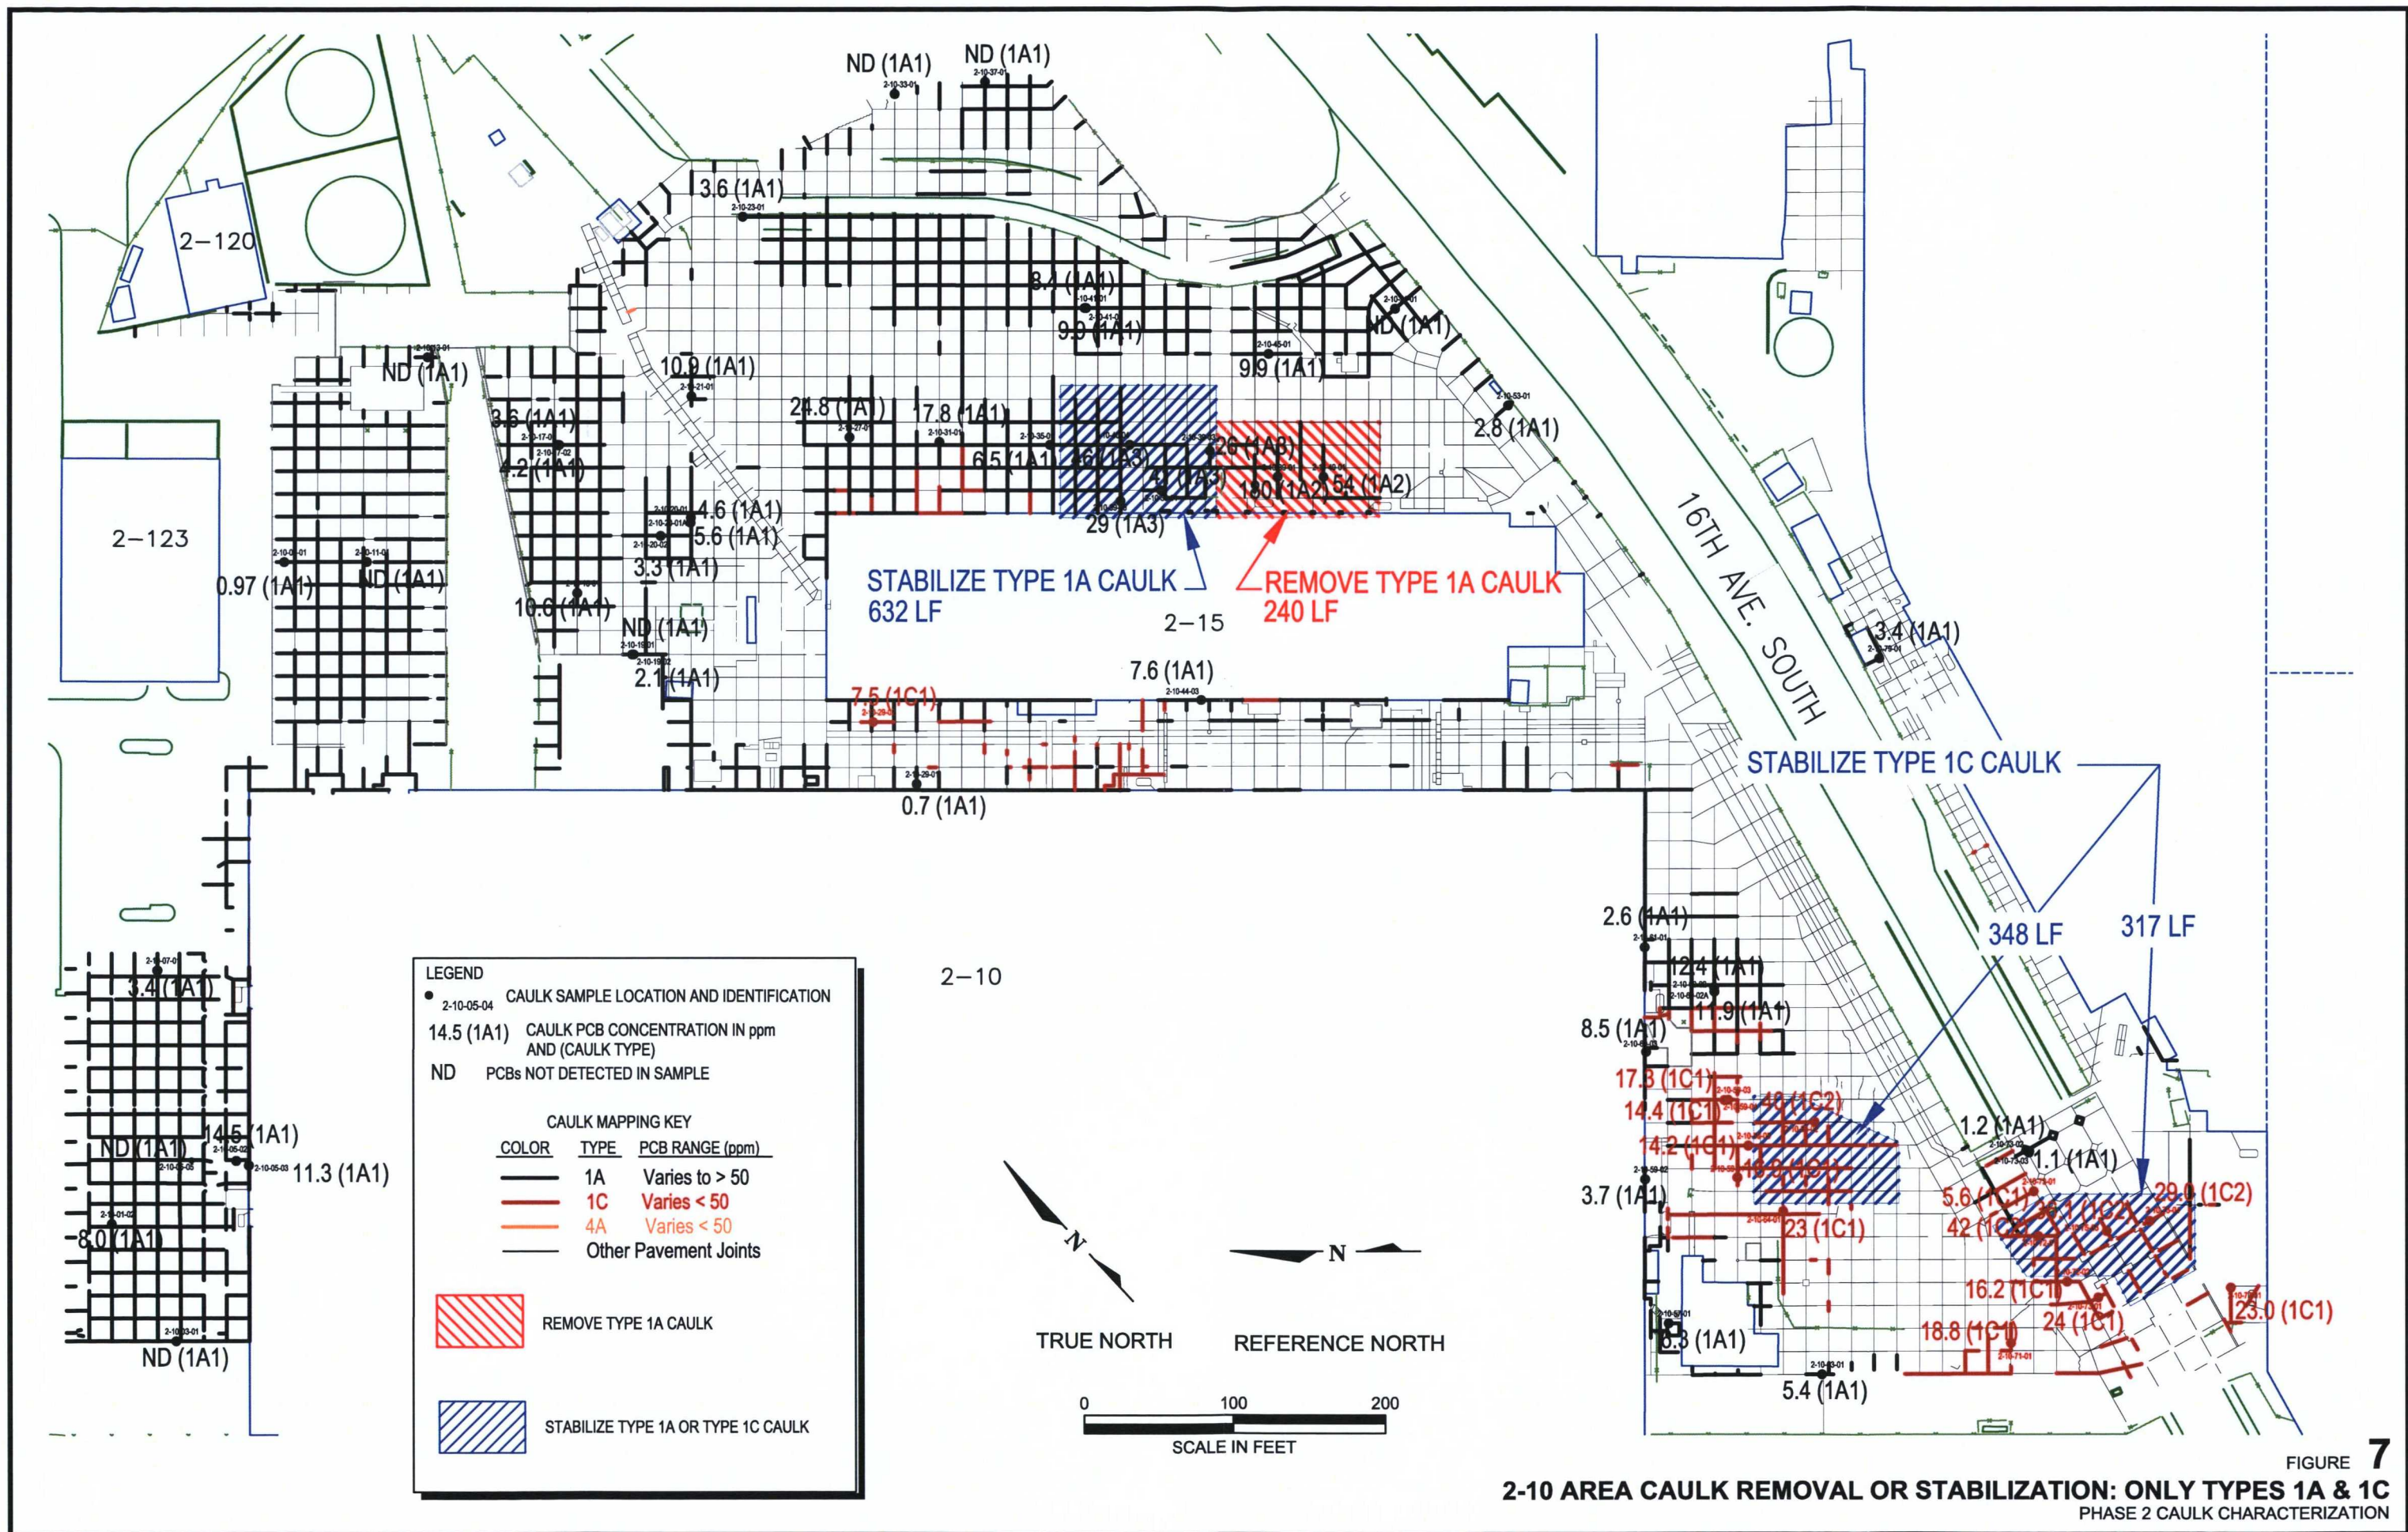
FIGURE 7
2-10 AREA CAULK REMOVAL OR STABILIZATION: ONLY TYPES 1A & 1C
 PHASE 2 CAULK CHARACTERIZATION
